EDDINGTON ELEMENTARY SCHOOL

ASSESSMENT REPORT

November 5, 2019

EDDINGTON ELEMENTARY SCHOOL BUILDING ASSESSMENT

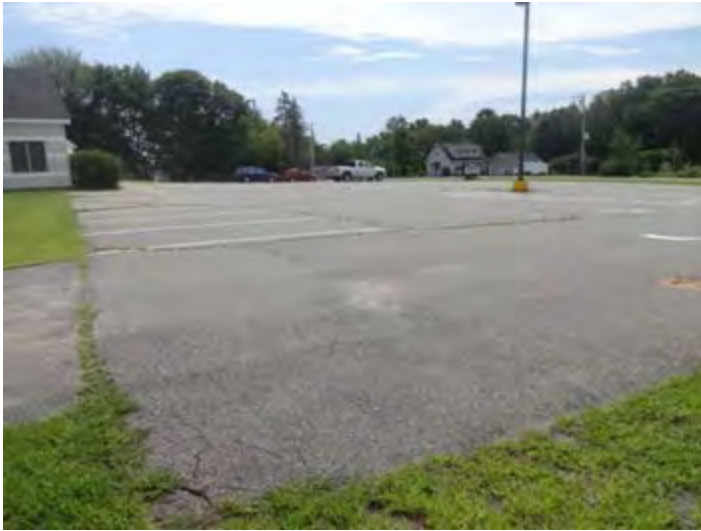
Paving

The large front parking area provides an adequate student bus drop-off route and parking spaces. There is a dedicated entrance and exit from the parking lot. The pavement is in fair condition with large cracks scattered across the site. A paved drive extends around the building and is in fair condition. At the rear is a large paved playground area that was paved in 2015 and in good condition. There are concrete slab entrances are in the front entrance and side gymnasium entrance. The concrete is in good condition with some weeds growing out of the joints.

Action: Crack seal joints to extend the life of the existing pavement

Action: Pave remaining area (1½” overlay).
(Priority 1 if piping is replaced for sprinkler system)

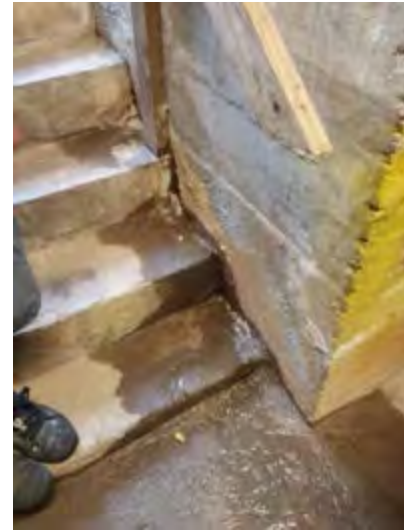
Mechanical Room

The boiler room is located under the original building. The boiler room is in poor condition. The ceiling has numerous holes and penetrations due to water leaks, poor installation of piping, supports, and the age and material of the ceiling. All boiler rooms require the rooms to be completely sealed and rated. Infiltration of ground water from utility trenches is a problem and a sump pump is used to evacuate the water. Within the last 5 years the power was lost and the sump pump failed, which caused the boiler room to flood to the ceiling. The flooding

has happened several times in the life of the building. Much of the equipment is damaged and must be replaced. The electrical equipment is located here also and it is a very corrosive environment and unsafe condition.

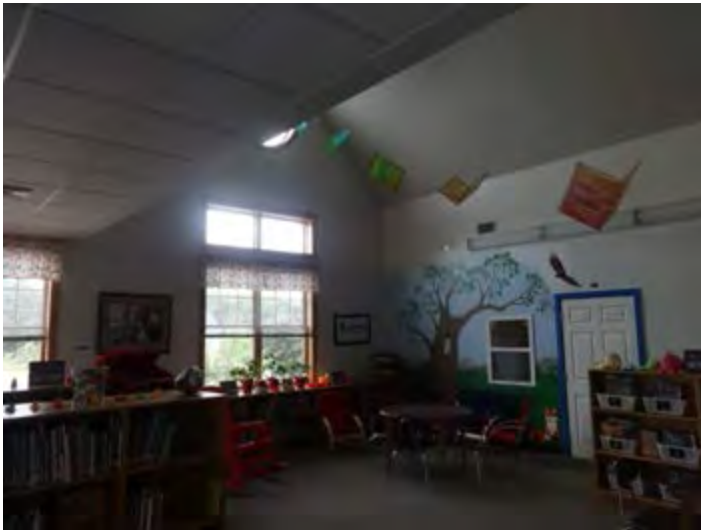
Classroom Windows

The majority of the windows in the 1955 building are older vinyl double-hung replacement windows in poor to fair condition, some of the windows are easy not easy to open and close. Staff has reported air infiltration in the winter. The 1992 additions have original vinyl clad double hung windows in fair to good condition.

Replace the exterior classroom windows with new vinyl single-hung replacement windows. Modern windows are much improved with higher R-values and should improve energy savings. Monitor the condition of the 1992 windows (36) for replacement in the future.

Action: Replace classroom windows (40) *Priority:* 2 \$ 35,000

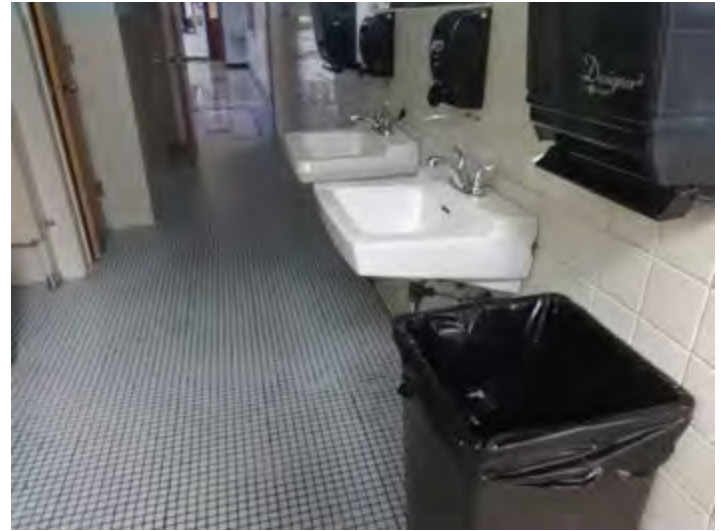
Bathroom Tile Flooring

The school has a combination of flooring. Most classrooms have vinyl asbestos tile in poor condition. The hallway was encapsulated with VCT in the hallway in fair condition. The gang bathrooms in the classroom area have ceramic tile flooring in fair condition. The individual classroom and unisex bathrooms have VCT. Carpet is in place in the library and main office area and is in good condition. The gymnasium/stage consists of VCT floor in good condition. The kitchen has VCT flooring in fair condition. The vestibules also have VCT flooring in good condition.

Action: Replace gang bathroom ceramic flooring.

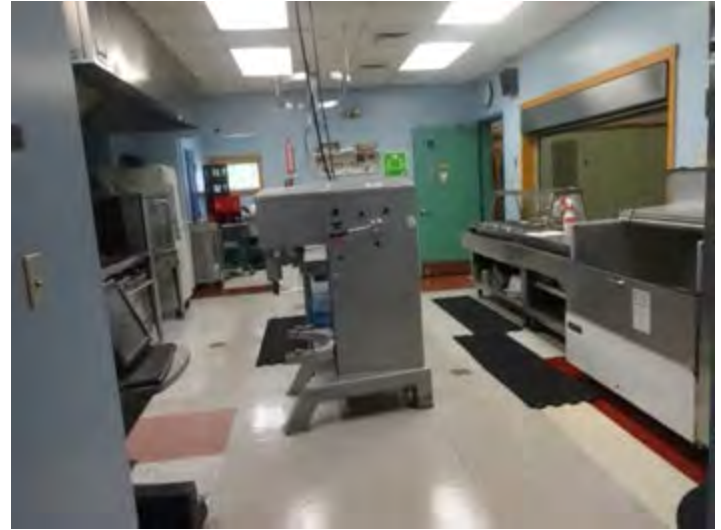
The Kitchen is a full commercial kitchen with appliances, walk-in freezers, coolers, ranges, ventilation hoods, wash stations, and serving lines. The condition and operation of equipment and interiors appear to be in good order. The kitchen hood and makeup air unit did not appear to be operational during testing. The units should be studied further to ensure adequate ventilation and exhaust rates are being met.

Action: Perform a kitchen ventilation study to determine if equipment meets ventilation rates required and replace hood. *Priority:* 1 \$ 50,000

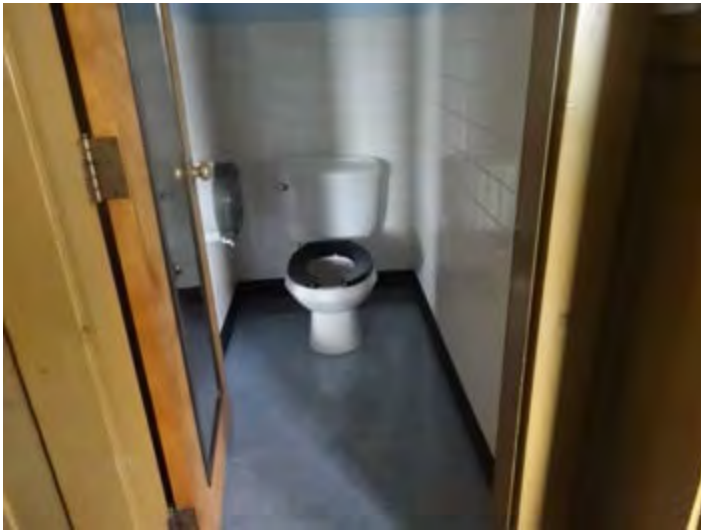
Student multi-stall restrooms, as well as a few single use restrooms for the faculty and library, are placed throughout the facility. The restrooms appear to be in fair to good condition. The flooring, walls, and ceilings have been addressed earlier in this narrative. Restroom plumbing fixtures are separated by painted metal partitions. For the most part the restroom plan and fixtures meet ADA standards for handicap accessibility; however several conflicting clearance issues were noticed. Also, the installation of a molded wrap on the exposed drain piping under the restroom lavatories is required. It was noted that not all restrooms had the appropriate grab bars and some toilet accessories mounting heights were not current with ADA code.

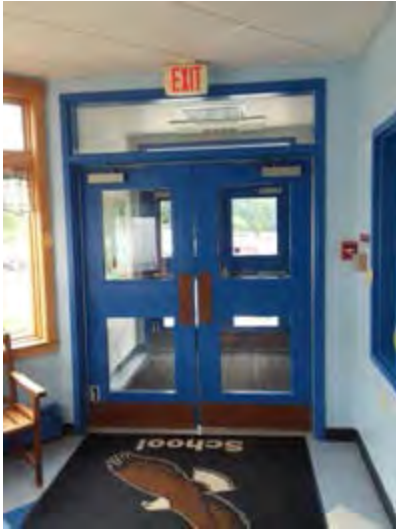
Main Entrance

The Front Entrance is non-secure in the present configuration. Once visitors enter the building, it is up to them to check into the office, which is located off from the Lobby. Any visitor could roam the school once in the Lobby before registering at the front office. Other doors around the building should be secured with access control hardware. Recommend implementing a card-reading system.

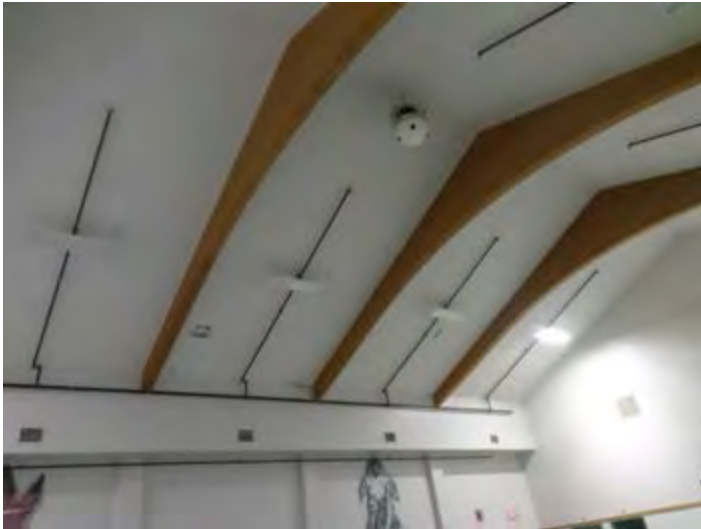
Gymnasium Lighting

A variety of lighting fixtures are in place throughout the classrooms and common areas. The majority are fluorescent fixtures and appear to be in fair condition. Energy savings can be improved with newer LED style light fixtures that also come with occupancy sensors to shut down lighting when not being used. Replacement should result in noticeable energy savings.

Action: Replace interior lighting with LED fixtures throughout.

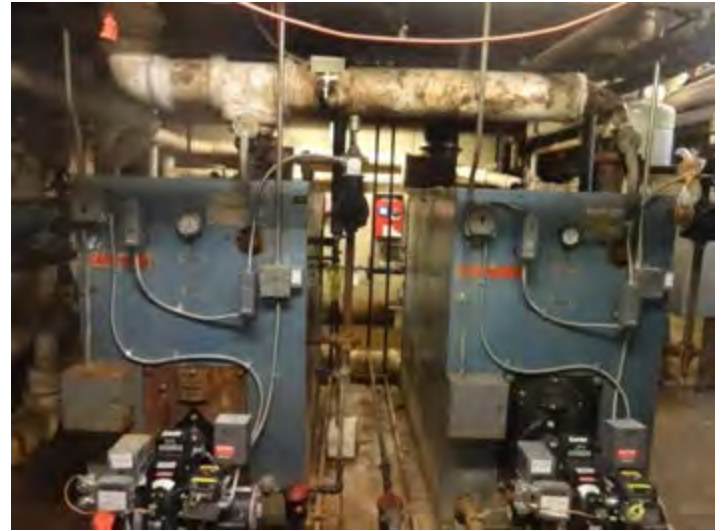
Boilers

heating oil from an underground 5,000-gallon storage tank. The underground storage tank has a severe water infiltration issue. The water appears to be entering through the foundation as well as near the surface due to poor grading of the surrounding asphalt. The boilers utilize Carlin burners. As part of the heating plant, there are numerous pumps, tanks, and supply and return piping. Consider replacing the original boilers as they are past their useful lives. The pumps that distribute the hydronic heat to each wing are single speed. We recommend replacing the pumps with new variable speed pumps, which will help reduce energy consumption. The piping that is connected to the boilers is in poor condition and should be replaced alongside the boilers.

| <u>Action:</u> Replace original boilers and burners. | <u>Priority:</u> 2 | \$100,000 |
